# Manhole Inspection Summary

# Manhole # S29GG\_014MH

Insp Date: **1/2/07 10:51 AM**

**Location** Address: **307 MOSHER ST**

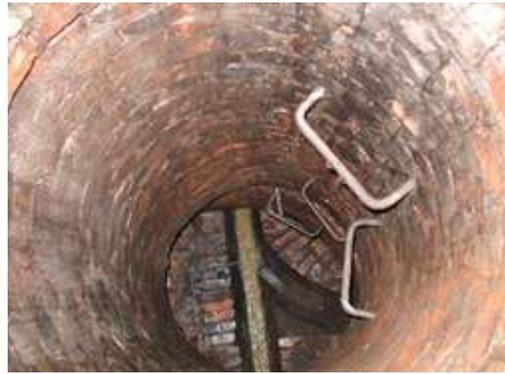
Top View

Evidence of surcharge - Bench debris.

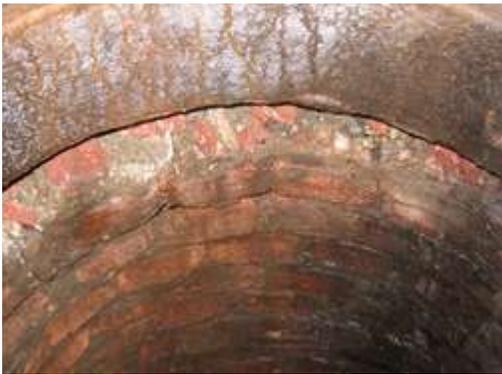
Defect

Frame leaks. Frame offset. Adjustment deterioration and infiltration. Corbel infiltration.

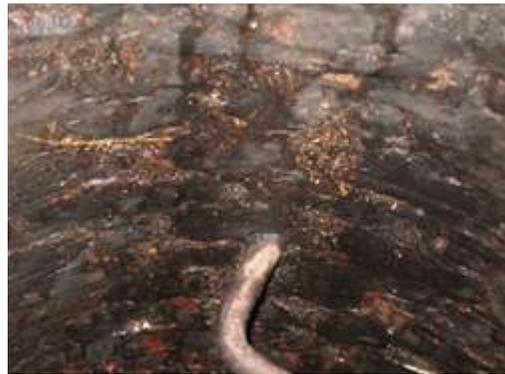
Defect

Barrel root intrusion and infiltration.

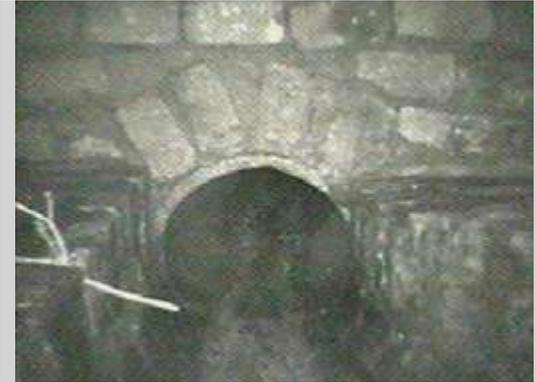
## 8 in. Circular Gravity Sewer Pipe Out @ 12 O'Clock

Invert Depth: **10.62** (ft.) Flow Characteristics: **Slow**

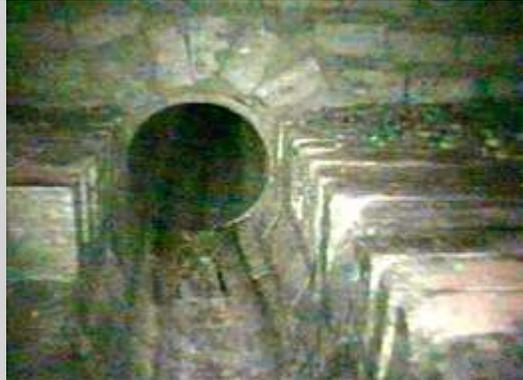
Pipe In @ 6 O'Clock

Infiltration: **Evidence** Pipe Seal Cond: **Unknown**
